AN INVESTIGATION INTO THE LOW CYCLE
COMPRESSIVE FATIGUE FAILURE MECHANISM
OF A COMPOSITE MATERIAL

SUBMITTED IN PARTIAL FULFILLMENT
OF THE REQUIREMENTS FOR THE DEGREE OF
NAVAL ENGINEER
AND THE DEGREE OF
MASTER OF SCIENCE IN OCEAN ENGINEERING
AT THE
MASSACHUSETTS INSTITUTE OF TECHNOLOGY

June 1970

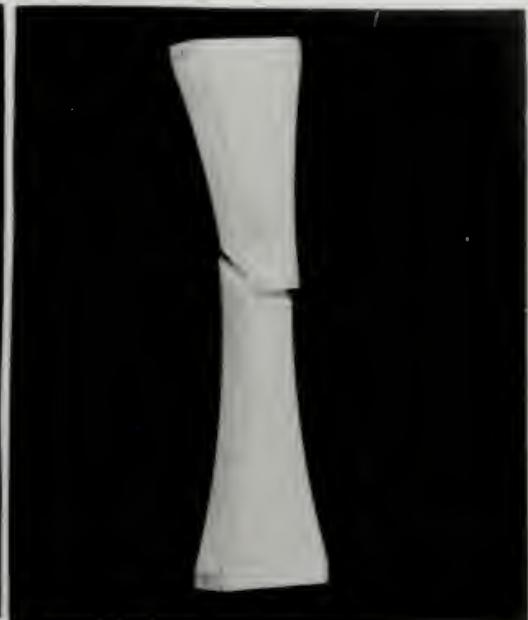
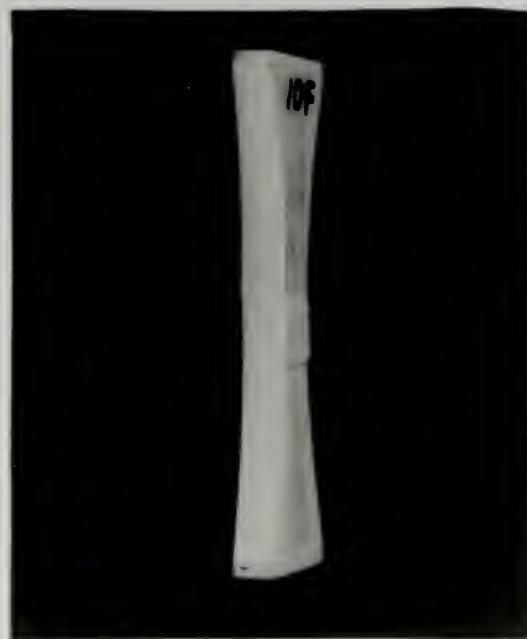
Typical Failures

- (1) A slant fracture type of shear rupture along a single fracture plane inclined approximately 45 degrees to the load axis.
- (2) A double slant fracture, or "single V", with either side of the V inclined at approximately 45 - 60 degrees to the load axis, and extending throughout the thickness of the specimen.
- (3) A multiple slant fracture, or "double V", in which a second V is added to the single V fracture, usually extending through only part of the thickness.

Typical examples of the above variations in shear failure can be seen in Figure 3. A fourth type of failure, not shown, occurred when the support jig was not used. In this case, failure occurred by delamination and buckling of individual plies, usually starting at the outer surface plies and progressing inward toward the center of the specimen.
